Effects of Concentrated Hydrochloric Acid Spills on Aircraft Aluminum Skin

July 1998

DOT/FAA/AR-TN97/108

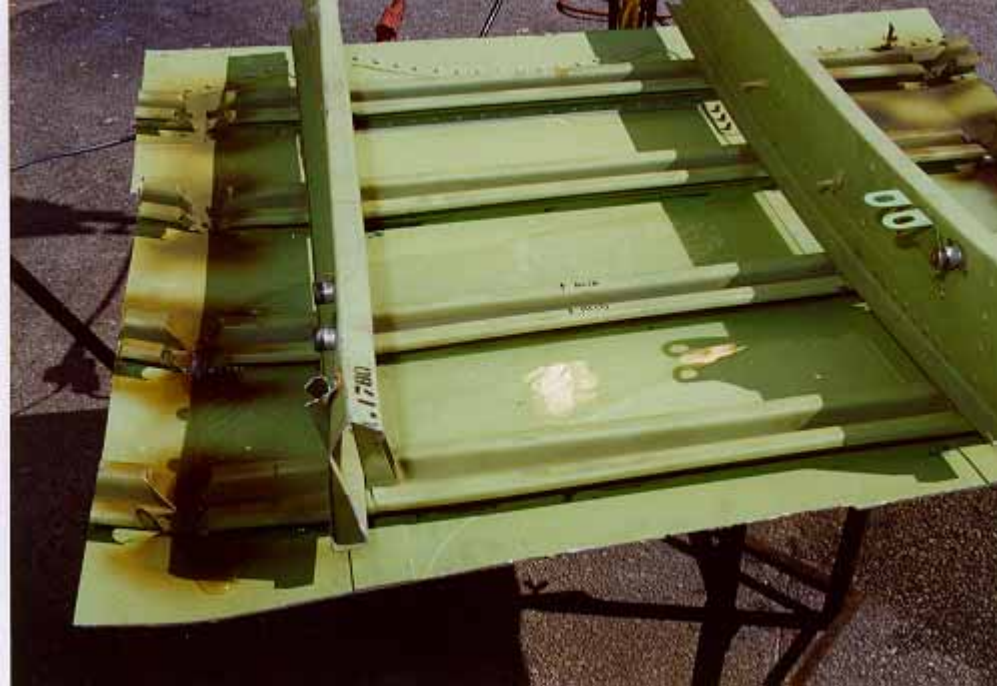
The first test was the largest, a 3- by 3-foot section with a 1-liter acid spill (figures 1 and 2). The edges of the skin were bent upwards to contain the acid. In the process of bending the skin and cutting notches in the ribs to allow the bending of the frame, scrapes and breaks in the surface coating of the aluminum skin were produced. There was no treatment of the marred surfaces in this test. The acid contacted not only the interior skin surface but also the bulkhead plates and fittings and the ribs and attaching grommets.

FIGURE 1. TEST ARTICLE FOR TEST 1: 3- BY 3-FOOT SIDEWALL OF A BOEING 747

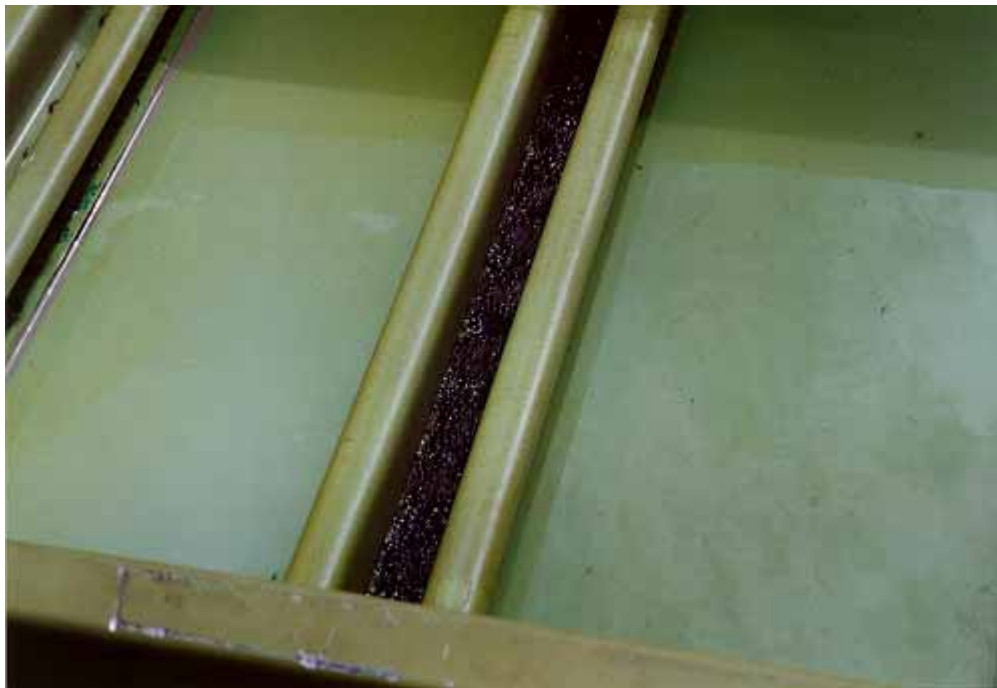
FIGURE 2. TEST 1 IN PROGRESS WITH A 1-LITER SPILL OF CONCENTRATED HYDROCHLORIC ACID

Test No.	Test Article Description	Location of Failure	Time to Failure (min.)	Comments	Figure No.
1	3' x 3' section of fuselage	At scratched surfaces and at bends in skin At rivets	47, 65, and 80 No failure	Acid created hole in skin at scratched and bent surfaces. Rivets partially decomposed, but still intact.	1, 2
2	6" x 6" section of aluminum skin in a 7" x 7" Pyrex pan	At rivets At ribs At rivets	50 70 80 85	Three rivets eaten away below surface of skin. Side of rib eaten 1/2 inch through the length of rib. Severe corrosion. All submerged surfaces of unpainted rib completely gone. Only white exterior paint remained where rivets were.	3
3	7" x 7" section of aluminum skin as base of pressurized box, 0-2.5 psi. Silicone caulk used as a seal.	At rivets At ribs	N/A 90	Severe corrosion. Rivets eaten through below surface of the skin. Rib disconnected from aluminum skin. All submerged surfaces of unpainted rib completely gone. Base seal remained intact. Pressure not maintained during the test due to failure of lid seal.	4, 5, 6

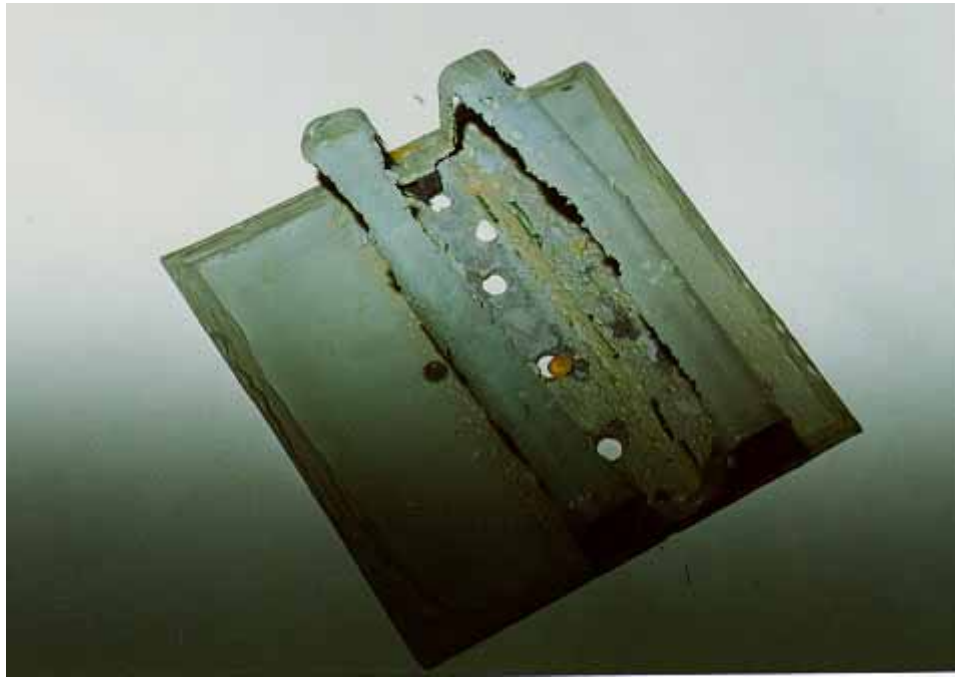
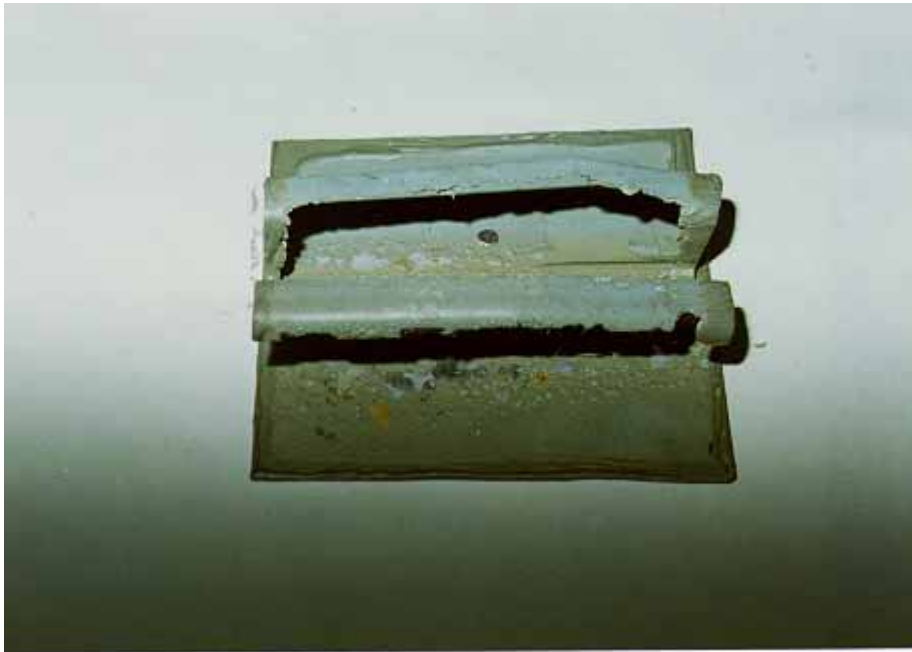
A 6- by 6-inch section of the skin, including the frame material, was placed in a Pyrex pan with the outside surface of the skin face down. All cut edges of the test sample were covered with epoxy paint. One liter of concentrated HCl was spilled into the Pyrex pan. The depth of acid was 1 1/4 inches. Periodically the section of skin was lifted out of the solution with metal tongs to visually evaluate the damage as a function of exposure time. The test specimen was rinsed with tap water at the conclusion of the test and photographed (figure 3).

FIGURE 3. TEST ARTICLE FOR TEST 2 AFTER REMOVAL FROM PYREX PAN CONTAINING 1 LITER OF CONCENTRATED HYDROCHLORIC ACID, TWO VIEWS

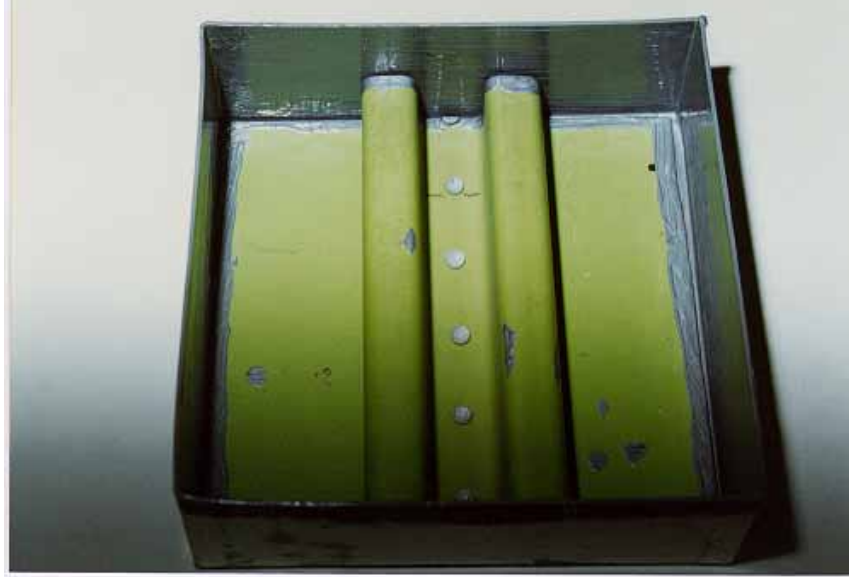
A 7- by 7-inch section of aluminum skin was used as the base of a box (figures 4, 5, and 6). All cut edges of the test sample were covered with epoxy paint. The test specimen was caulked to the bottom of a shallow aluminum box with silicone caulk. The bottom of the box was cut out to be slightly smaller than the test specimen resulting in a high-contact surface of the silicone caulk with both surfaces. An epoxy coated metal lid was caulked in place over the aluminum box. The lid contained two Teflon swagelok bulkhead unions. The box was pressurized with nitrogen from 0 to 2.5 psi.

FIGURE 4. TEST ARTICLE FOR TEST 3 PRIOR TO ACID SPILL

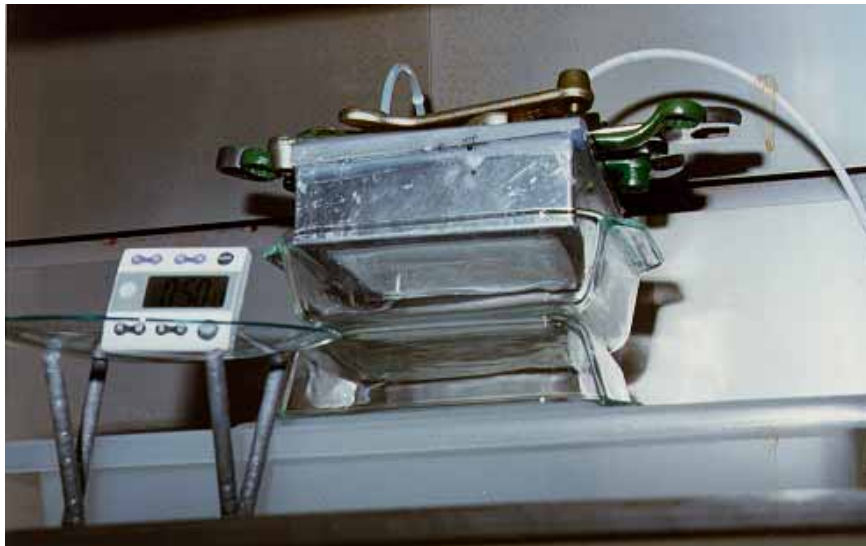
FIGURE 5. TEST 3 IN PROGRESS WITH A 1-LITER SPILL OF CONCENTRATED HYDROCHLORIC ACID

A 2.5 psi box pressure simulates the ΔP_{skin} at 15,000 feet altitude. A small ΔP may result in the blowout of the white exterior epoxy paint on the bottom of the box when the rivets fail, giving a visual indication of failure. However, the silicone lid seal failed early into the test and pressure fell to ambient.

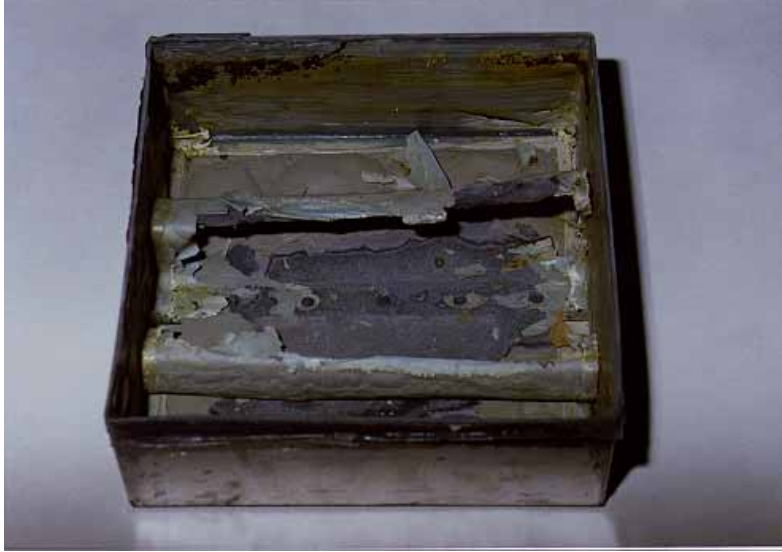
FIGURE 6. TEST ARTICLE FOR TEST 3 AFTER A 90-MINUTE CONTACT WITH SPILLED CONCENTRATED HYDROCHLORIC ACID. TOP OF TEST CONTAINER REMOVED.

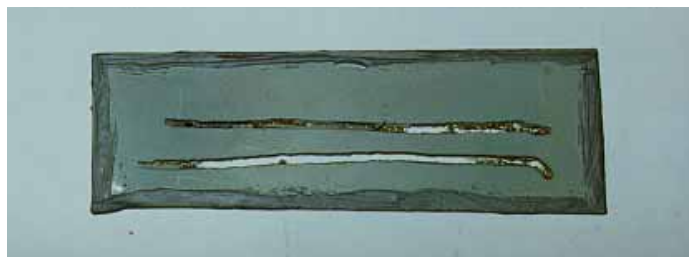
FIGURE 7. TEST ARTICLE FOR TEST 4. SCRATCHED B-747 SKIN AFTER REMOVAL FROM PYREX PAN CONTAINING 1 LITER OF CONCENTRATED HYDROCHLORIC ACID.

4	One scratched strip of aluminum skin, 2" x 6 3/4" in a 7" x 7" Pyrex pan	At scratches	60-90	Acid created hole through the aluminum skin along the scratch. The white exterior epoxy paint was wrinkled, but the seal remained intact.	7
